COOK LEGACY CASE STUDY

Majer, Iraq Water Treatment Plant

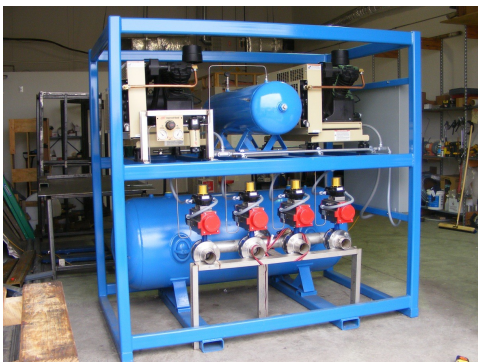
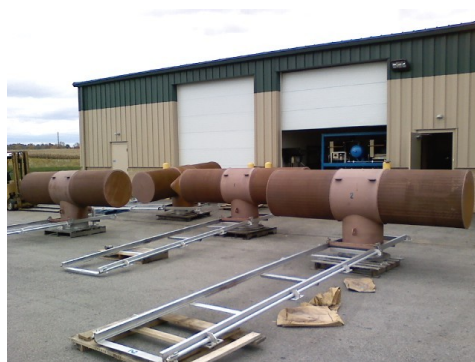
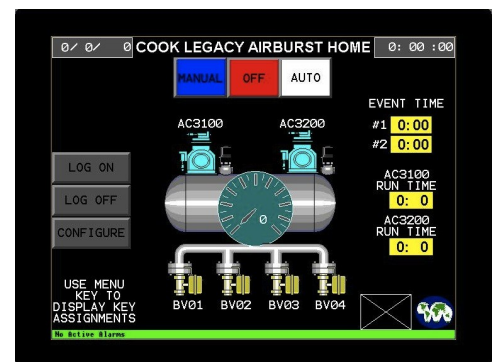
Soon water from the Tigris River will flow through screens designed and built by Cook Legacy. Cook Legacy provided an Intake and AirBurst System for installation at a water treatment plant in Iraq. The ancient waterway is also rife with biofouling problems. In response, Cook Legacy built four screens with its proprietary Jacquelyn Coating™. The system also had to be durable enough to stand up to Iraq's harsh environment.

To address the language barrier Cook Legacy modified our RAMA™ control system to make a panel that was operable based only on pictures and numbers. With our RAMA™ control software and third-party graphically based touch panel, we minimized any translation errors. We designed unique interactive screens, like the one shown below, on which pictures represented a part or function in the system. For instance, if an operator presses a valve icon, that accesses the valve control page.
